Tell Hesban Restoration and Preservation Map

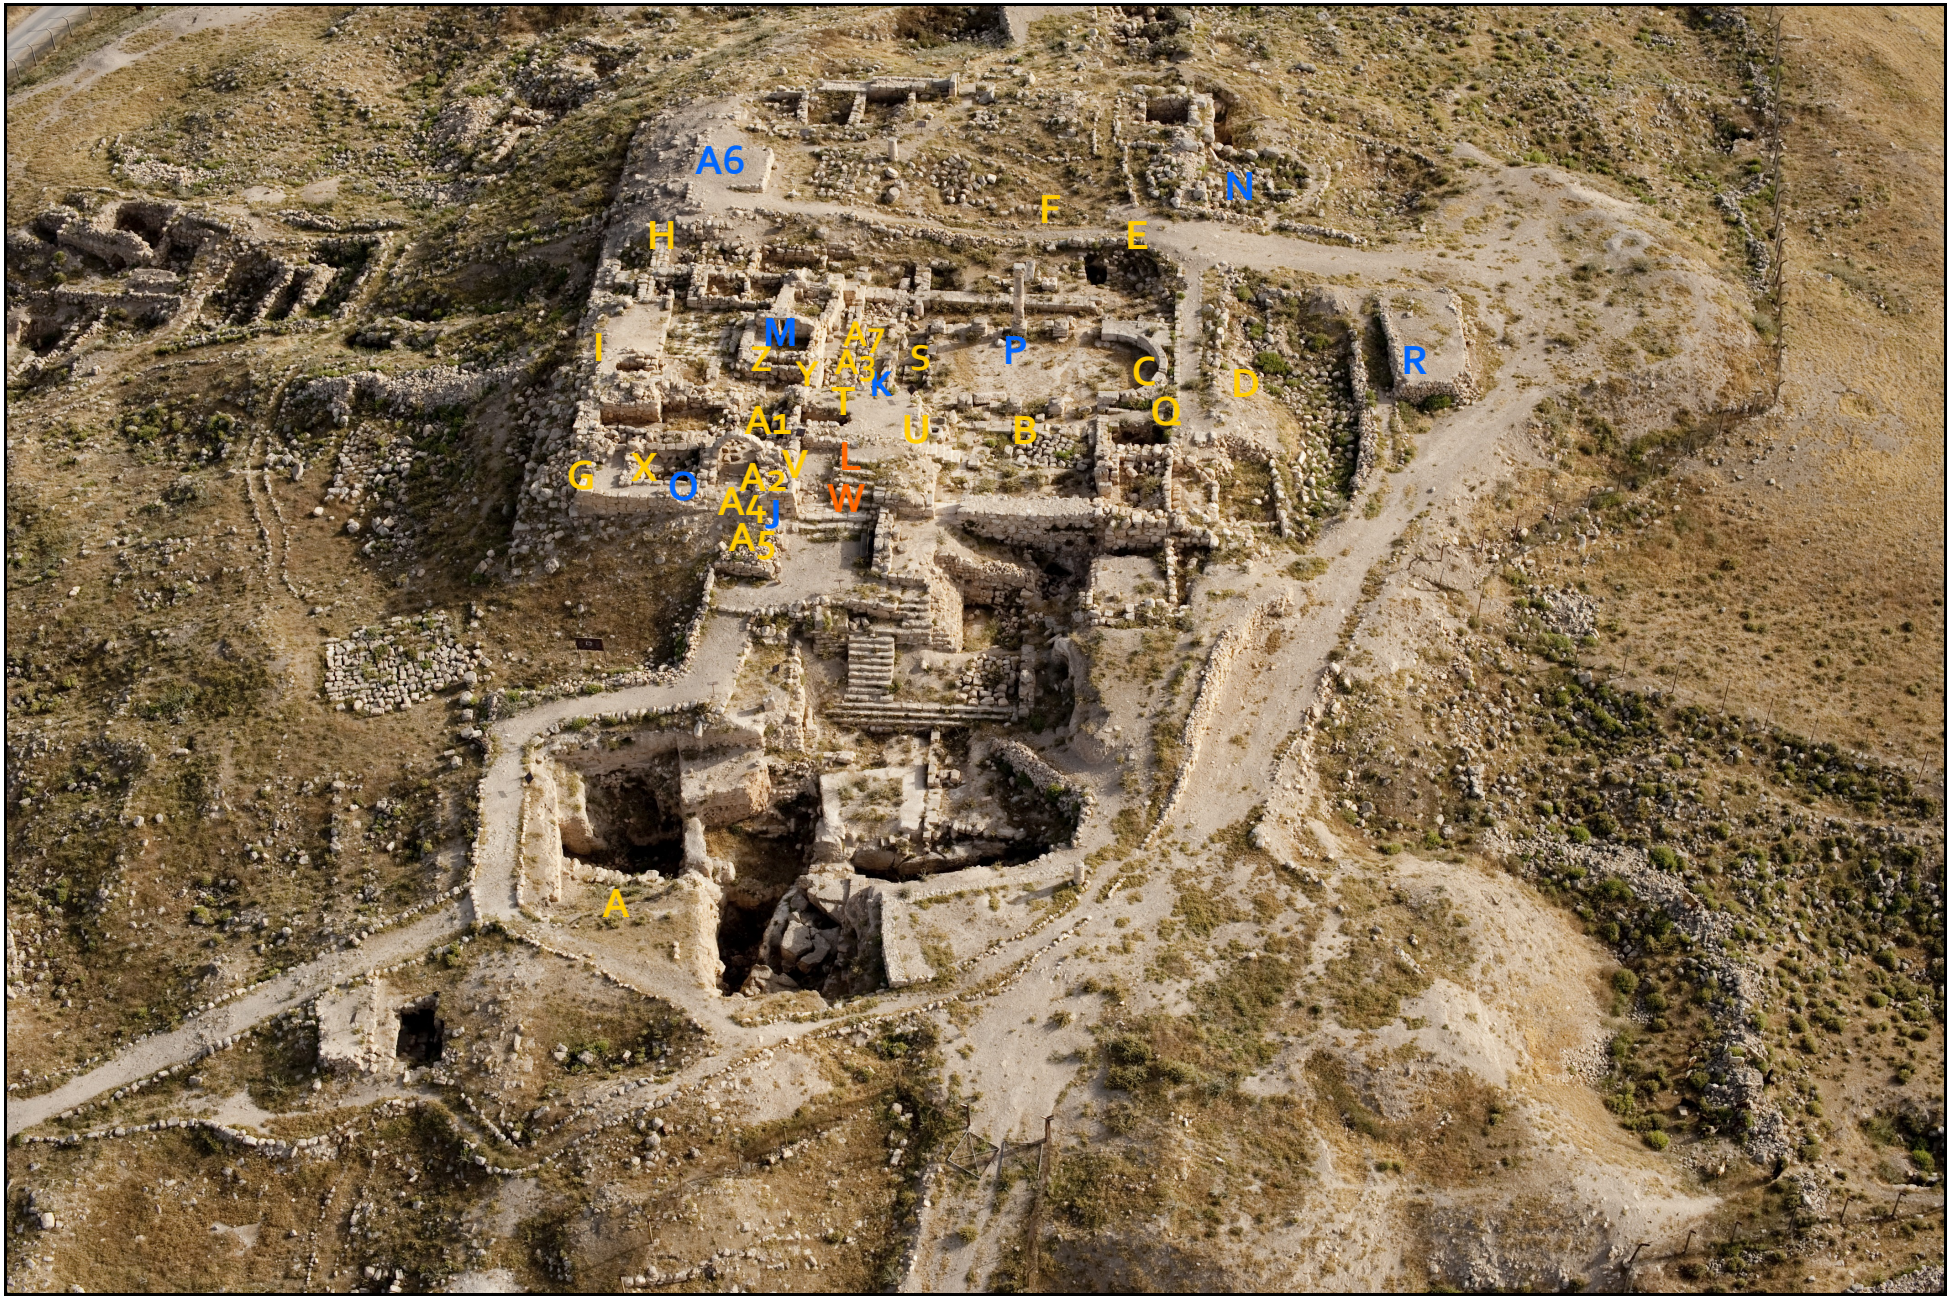
- A. Stone wall placed around pit where the east wall of the 9th century reservoir was, as well as a stone wall lining the eastward ridge which faces the Roman steps. All stones are unworked, and were found around the tell.

- B. Filling added to create a platform south extending out of the Byzantine church, between the Hellenistic wall and the south tower of the church. Platform fill consists of soil and worked rocks found scattered around the area which likely originated from the church structure.

- C. The cistern southeast of the Byzantine church had walls built and reinforced, and a step leading to the east walkway.
- D. The south end of the walkway behind the Byzantine church will be walled off for safety with scattered stones from the area which probably originated from the church structure.

- E. Steps are being fixed parallel to the north end of the walkway lying east of the Byzantine church.
- F. More stones, gathered from the surrounding area and likely originating from the church structure, were added to the east-to-west path lying north of the Byzantine church. Fill will be added to smooth it out.

- G. At the two store rooms on the southwest edge of the tell, Dr. LaBianca is suggesting a path to go along the west end of the store rooms, extending north-to-south and meeting the path that lines the south end of the southern store room.

- H. Two small rooms are being filled in directly south of the high view platform. The rooms will first be filled with sandbags, as well as an added layer of soil to smooth the surface and hide visibility of the sandbags. The fill will extend to the height of the room walls to create more walking space for visitors.

- I. The plaster floor of the Liwan of the Governor's Complex was covered in plastic for protection, and afterward dirt was added on top for protection.

- J. The south wall of the Mamluk tower was reconstructed after it was knocked over following the arch construction in 2004. Although the tower wall had been constructed in the 1970's and never was part of a tower structure, it was reconstructed.

- K. A collection of rocks collected from the surrounding area were placed

- down, forming a set of uncemented steps going from field Q toward the bath house in 1998.
- L. The first three steps leading up to the south side of field Q are in their original place, and the top two stone sets were added in the 1970's.

- M. The top courses of the south wall of the bath house were rebuilt in 2001, as well as the entire outer face of the east wall.
- N. The north enclosure wall of the summit was partially reconstructed in 2006. The top two courses of the wall had 10 stones added to each, and about five or six stones were placed back into their certain original position within the first two visible courses of the wall.

- O. Stones were removed from the store room excavations and placed around the southwest corner tower of the citadel, but this was not done with the intention of restoration.

- P. Two columns were raised up at the Byzantine church in 2005-2006, though only one remains standing today as the other was knocked over.
- Q. Southeast corner tower of Byzantine church north wall was recreated with local worked stones.

- R. Platform created in previous season for site viewing.
- S. Stairs formed with local worked stones which were originally from the citadel wall, leading from the platform east of the bath house, going down into the Byzantine church area, with additional stairs going up to the citadel.

- T. A sand bridge was built between Q1 and Q5, with 3 bags going east, 3 bags going west, 2 bags going north/south, and 6 bags tall.
- U. Sand bags were placed to hold up the stairs going up to the citadel that were created in 2004 on the base of the very top step. One bag is on either end, on the north and south ends, on the east side of the step, to reinforce the step.

- V. An enforced wall of unworked stones was constructed to the west of the original Byzantine stairs, just south of the wall in Q1, to better reinforce the plaster flooring.

- W. Only the first 2 or 3 of the steps in the original Byzantine stairs going

- to the citadel are original, and the others were added in the 1970's. Some repair work was done on the top of the original stairs with worked stones on the west side of the step.

- X. The store room to the west of the arch was filled with a layer of sandbags at the very bottom and topped with dirt for safety and walking space.
- Y. North of the arch, three stairs made of unworked stones were built leading down to Q8.

- Z. Workers reinforced the wall on the south side of the bath house with unworked stones.
- A1. To the west of field Q, north of the arch, workers cleaned up the north/south wall, removing rubble and plants.

- A2. On the inside of the citadel wall, southeast of the arch, workers filled in the corner of what used to be called the Mamluk tower, filling it in with pebbles and dirt to smooth out the surface.

- A3. The upper portion of the wall on the north side of field Q was reconstructed in the 1970's.
- A4. Two steps made of worked stones were placed directly south of the arch, slightly to the east, near the area workers leveled off in the corner tower, mentioned above in figure A2.

- A5. On the smaller of the two south citadel walls in the double wall system, workers cleaned and filled in the interior of the walled area to reinforce the restored work with pebbles and unworked stones.

- A6. The high view platform was constructed previously for better viewing of the site.
- A7. A platform east of the bath house was constructed in the 2010 season for viewing.
